# CONCRETE REPAIRS TO FOOD FACTORY

ID: 9944

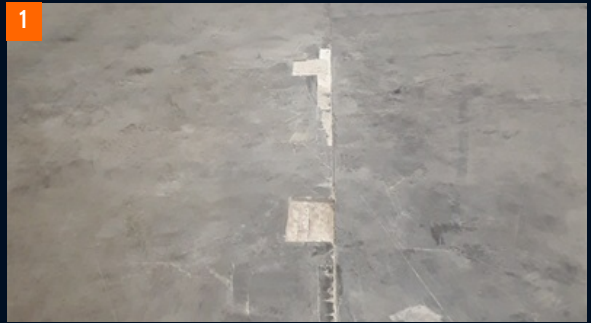
Various cracks and damage had been identified which caused issues for the hard-wheeled fork lift trucks and hand pallet trucks losing their loads

1. A general area to repair (Area 1)
2. Cracks, showing prep to sides and solid surrounding substrate
3. Further damage to adjacent slabs, causing issues for FLT Traffic
4. Area 1 fully repaired and checked on some 5 years after, still in place, still performing

The client's team had actually saw cut some of the areas, which, whilst not normally necessary, made little difference to the application. Belzona 4911 was mixed and applied using a short bristled brush. Belzona 4131 was mixed as per the IFU and applied to the problem areas. The Belzona 4131 was compressed and dressed using a finishing trowel.

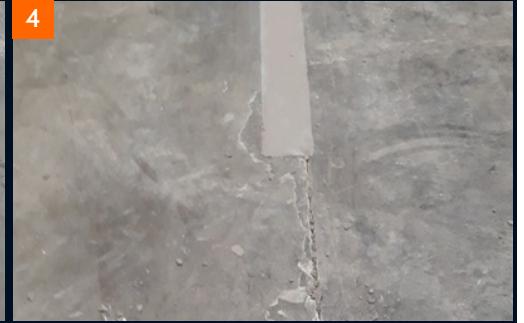
5 Years later, the repair is still performing with no signs of damage.
