# MIXED CHEMICAL SUMP LEAKING INTO WATER TABLE - SAVED

ID: 9945

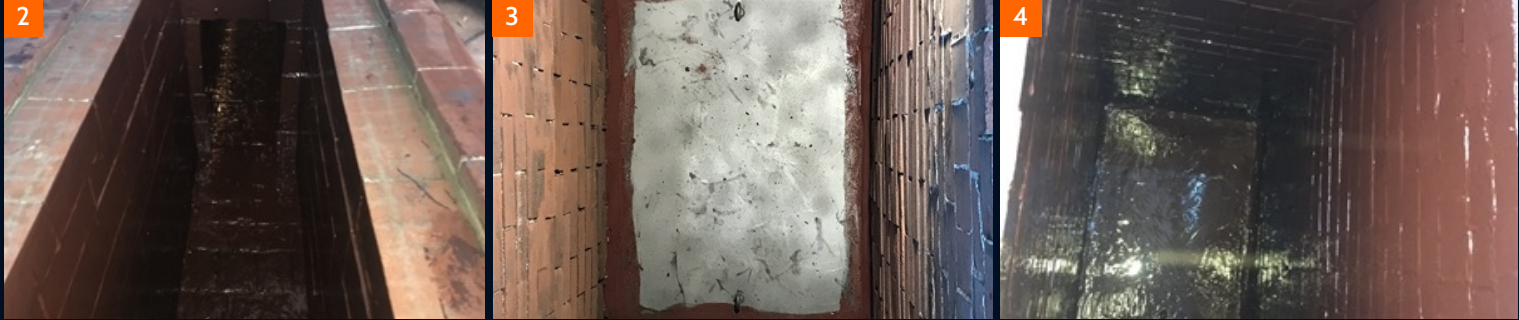
A trough handling spillage from a line of 10 chemical tanks would empty into a sump, creating a cocktail of various harsh chemicals. The sump was found to be leaking and urgent action was needed to contain and properly manage the waste.

1. Showing damaged sump with little in the bottom, following further leakage
2. The trough completely lined and sealed
3. A steel plate was employed to seal over the damaged floor, this was grouted in with Belzona 4311 CR1 prior to encapsulating the whole sump
4. The sump with a new base plate, completely encapsulated

Tank to be drained and initially cleaned by client.  
Clean the surfaces of the tank with the combination of jet washing and steam cleaning.  
Remove excess water and dry surface of tank as required.  
Prepare internal substrates by means of grinding to achieve the correct profile and surface cleanliness.  
Vacuum and sweep away any dust and debris from the application area prior to application of Belzona materials.  
Fit new base plate and flaunch in with Belzona 4311  
Mix and apply Belzona 4911 (Magma TX) to the prepared area of the bund.  
Mix and apply Belzona 4181 (AHR Magma Quartz) to the already conditioned areas at a minimum of 3mm.  
Repeat until the required areas are coated.  
Joint inspection of the works to be carried out.  
Clear and leave site

The trough had to be temporarily sealed to ensure that no further chemicals entered the working area of the trough end and the sump. The client could only find Belzona to offer a coating that would perform with such a mixture and cocktail of chemicals, these being Caustic Soda(Sodium Hydroxide) @ 29%-51%  
Phosphoric Acid @ 70% - 90%  
Hydrochloric @ 28%  
Nitric @ 60%  
The sump has been visited on an annual basis and the Belzona application is always found to be performing completely as expected
