# BELZONA PROTECTS CONTAINMENT AREA IN A WASTEWATER PLANT

ID: 9947

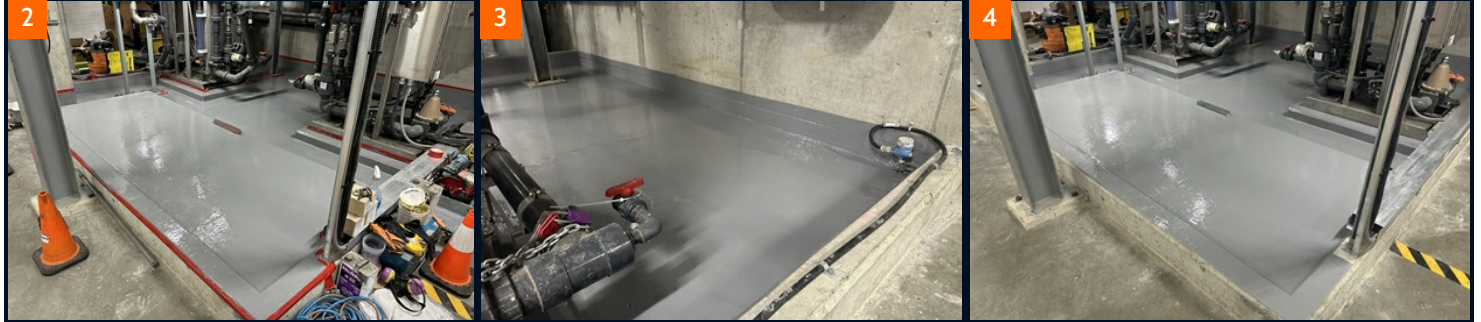
## PHOTOS

A recent leak in the containment area had water penetrating through cracks in the concrete into an electrical room below.

1. Photo of containment area with storage tanks removed
2. Application in progress
3. View of containment area
4. Finished application

A flexible coating was needed to bridge cracks and provide long term protection

The concrete was ground using diamond cup grinders with hepa-vac systems. Two coats of Belzona 5815 were applied by brush & roller.
