# REPAIRS TO CONCRETE FUEL STORE FLOOR

ID: 9949

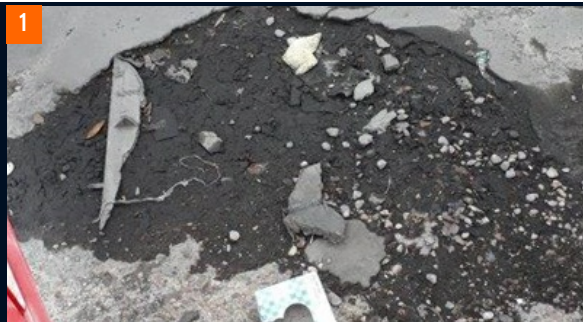
Repeat impact from the dropping of Oxygen cylinders, along with heavy lorry wear and tear had broken up large areas of the fuel store at a large distribution center

1. Broken floor with large holes and cracks due to impact
2. Works taking place to repair the damage
3. Works completed
4. 6 years on

Break out loose and friable materials and vacuum  
Apply Belzona 4911 to all target areas  
Mix and apply 4151 resins and 4111 aggregates  
Trowel off to compress and leave to cure

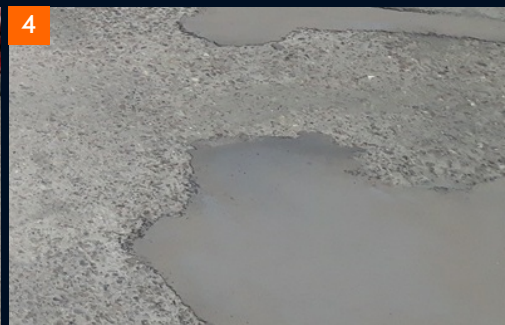
The most important aspect with this project was the available time to effect a repair. Belzona products proved invaluable to the ongoing operations of the distribution warehouse. 6 years on, the repairs are still performing as intended
