# BELZONA REFITS CRUSHER BEARING

ID: 995

New 12" dia. bearing had to be fitted to worn shaft on crusher

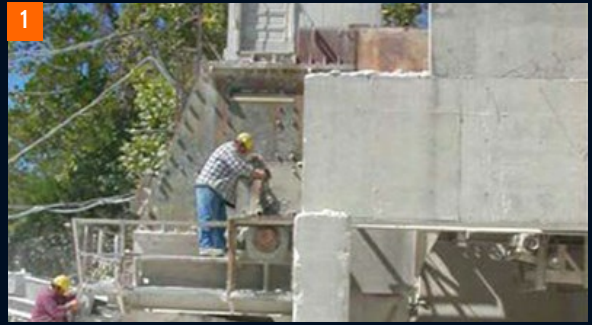
Overall view of the crusher  
Damaged journal  
Belzona 1111 applied on the journal  
Finished bearing refit
