# LOADING BAY CONCRETE REPAIR

ID: 9950

Constant lorry impacts had damaged a loading bay side wall

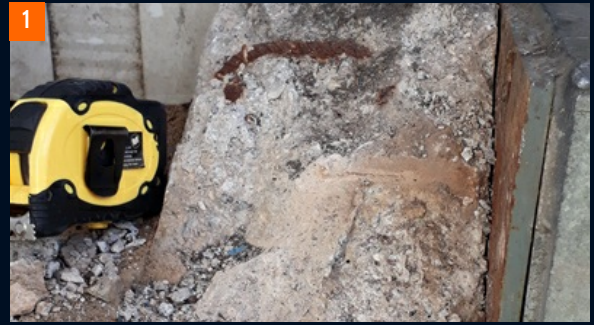
1. Damage to loading bay side wall
2. Showing a large repair needed
3. Repair completed
4. Repair some 5 years later showing scratched from lorries, but no real damage

Remove all loose materials and vacuum  
Mix and apply Belzona 4911 TX Conditioner  
Create former and apply Belzona 9411 release agent to internal surfaces  
Mix and apply Belzona 4111 and trowel off  
Allow to cure and remove released woodwork

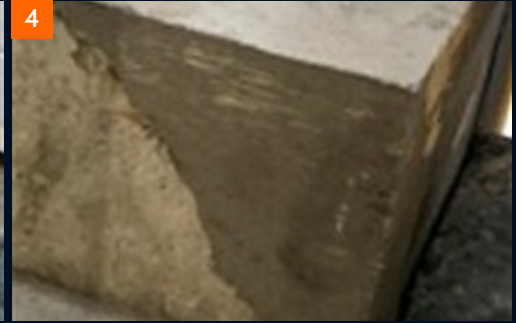
To recast concrete to this area would have been unsuccessful. The client needed a quick turnaround and an extreme durable product that would at least outlast concrete. 5 years on and the repair is still performing as expected, with a few scratch marks showing it's durability to heavy impact
