# BELZONA SOLUTION FOR FAILED EXPANSION JOINTS

ID: 9951

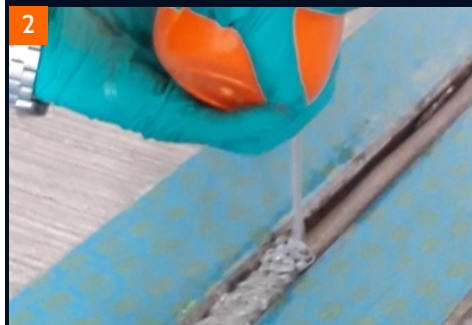
1. Area is prepared and foam backer rod is placed at the correct depth
2. Joint prepared and 4521 being applied
3. Pouring in the Belzona 4521
4. Completed works showing the Belzona 4521 still in its intended location

All target areas were cleaned and vacuumed, then masked along the sides to give clean lines

A foam backer rod was inset into the joint at a depth of half that of the joint's width
