# VALLEY GUTTER JOINT REPAIRS

ID: 9952

## PROBLEM

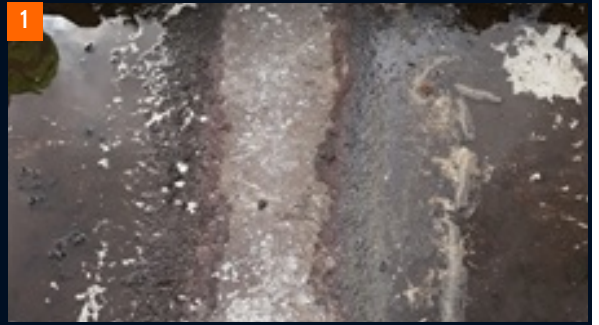
1. Areas of probable leaks were identified on external inspection of the high bay
2. All joints were identified and marked on an aerial plan
3. Obvious issues were showing and Belzona was the chosen solution
4. 6 years on and the repairs to the valley gutter joints continue to protect.

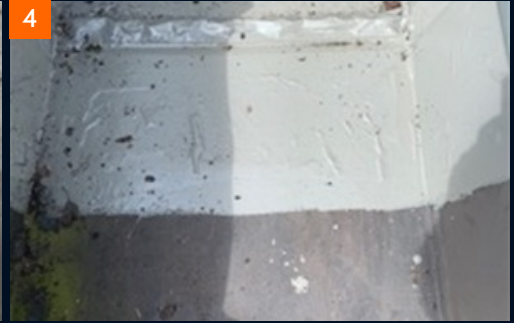
Many other materials had been tried, all had failed. Belzona were a trusted supplier to the client so it was decided to use the Belzona 3121. 6 years later, there have been no further issues with the Valley and side gutter joints
