# BELZONA REPAIRS TO A SEVERELY ERODED COPPER CASTING PUMP

ID: 9953

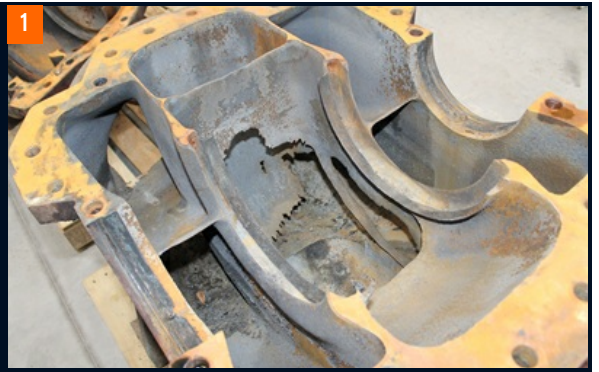
This pump had severe erosion damage with multiple through-wall defects. Their new pump wasn't due to arrive for six months, and the pump needed to remain operational until that date

1. Severely eroded pumps with multiple through wall defects
2. Pump is grit blasted to minimum surface profile
3. Through wall defects and missing metal is rebuilt
4. Two coats on Belzona 1391T are applied to protect against erosion/corrosion at high temperatures under immersion
