# BELZONA SYSTEM REPAIRS AREAS TO WET PULP SCREW CONVEYOR

ID: 9957

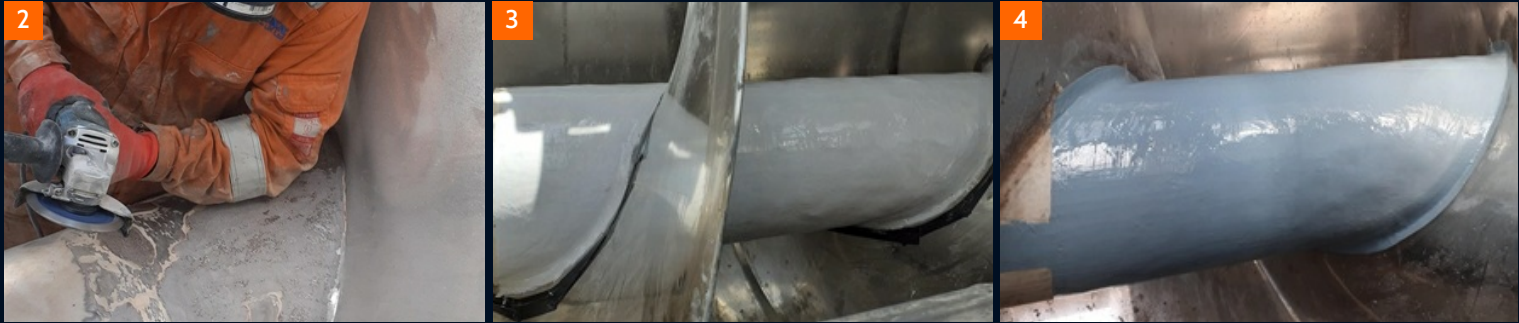
**PHOTOS**

A Wet Pulp Screw Conveyor with localised areas of erosion and scoring. These defects were causing process issues and preventing the conveyor from operating at its optimum capacity.

The three areas of concern are located on the shaft only, affecting three separate sections between the screw flights. The customer requested that the screw remains in position and worked on in situ. To carry this out, we required the equipment to be safely isolated but free to rotate in order to aid surface preparation and application of the Belzona system.

1. wet pulp screw conveyor with localised areas of erosion and scoring
2. The affected areas are prepared to minimum surface profile using hand tools
3. Surface is rebuilt using Belzona 1311 (Ceramic R-Metal) and reinforcement sheet
4. Two coats of Belzona 1391T adds protection to the screw conveyor

To limit disruption, the application areas were prepared using power tools only, in accordance with SSPC-SP11. Once prepared, the areas will be thoroughly cleaned. Any sections showing loss of profile were rebuilt back to standard using Belzona. Following this, the full circumferential repair areas were reinforced using Belzona 1311 and Belzona 9341 then be left to stabilise overnight. The following morning, the repaired areas were inspected and then received two coats of Belzona 1391T.
