# BELZONA 5815 CONTINUES TO PROTECT CONCRETE SWITCHYARD - 14 MONTHS IN SERVICE UPDATE

ID: 9961

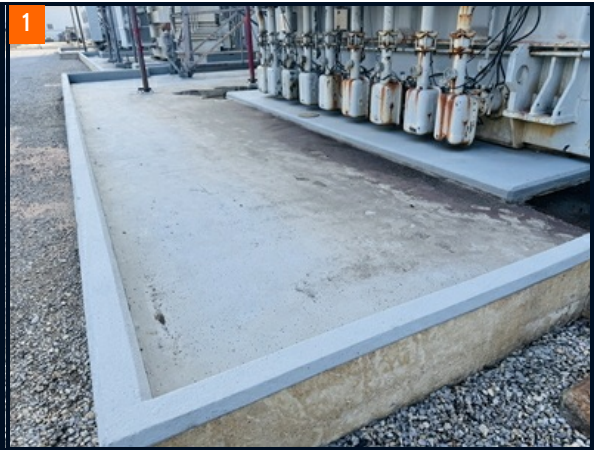
1. Belzona 5815 pictured (14 months in service)
2. Belzona 5815 pictured (14 months in service)
3. Belzona 5815 (14 months in service) used with 9371 composite reinforcement tape. This was applied to all seams and perimeters where the walls met the floor.
4. Belzona 5815 (14 months in service)

With no prior coating, our client used a 3500psi + pressure washer to clean and create a profile on existing concrete. Any damaged concrete or unlevel areas were repaired with Belzona 4111. Gaps and seams that could limit containment, were filled with caulk and sealed with Belzona 5815 and 9371 composite tape to reinforce. (2) coats of Belzona 5815 were applied. #16 aluminum oxide aggregate was broadcasted into the second coat for a non skid effect.
