# BELZONA SF6-FIX ON A VOLTAGE TRANSFORMER IN THE POTASH INDUSTRY

ID: 9962

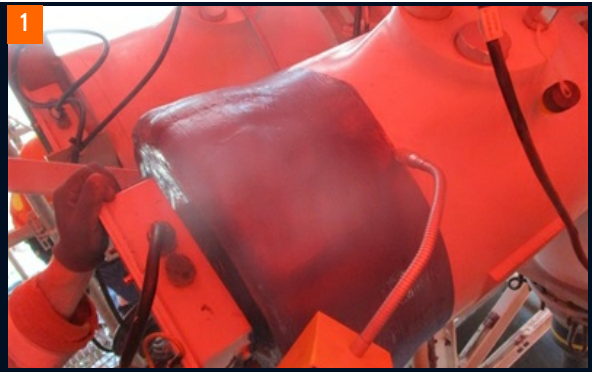
1. Completed SF6-FIX application with final layer of Belzona 7311
2. Media blasted surface preparation of the bond areas. Breather tube flange and membrane applied over the flange area after this step.
3. First layer using Belzona 7311 and 9341 open mesh reinforcement fabric over the breather membrane and breather tube.
4. Second layer using Belzona 1981 SWII resin and 9371 glass fiber reinforcement tape.

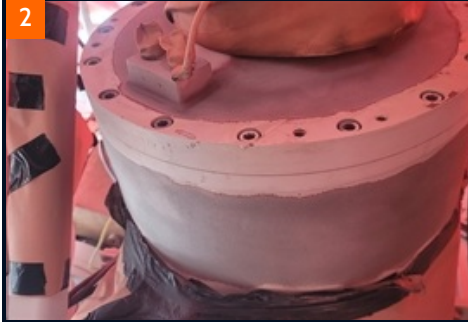
The bond areas were grit blasted, and a breather tube and breather membrane were installed over the flange to channel any leaking gas away from the repair area, preventing defects while the material cured. The first layer of Belzona 7311 was applied, with 9341 reinforcement mesh placed over the flange area and extending onto the bond area. Belzona 1981 resin and 9371 glass fiber reinforcement tape were then applied in five layers over the flange area and onto the bond area. Once cured, the surface was prepared to a frosted appearance, and the final layer of Belzona 7311 was applied. After curing to the full service level specified in the IFU, the system was brought back online. SF6 leak testing was conducted, and no leaks were detected.
