# BELZONA IS KEEPING THE PORT CRANES CORROSION FREE

ID: 9963

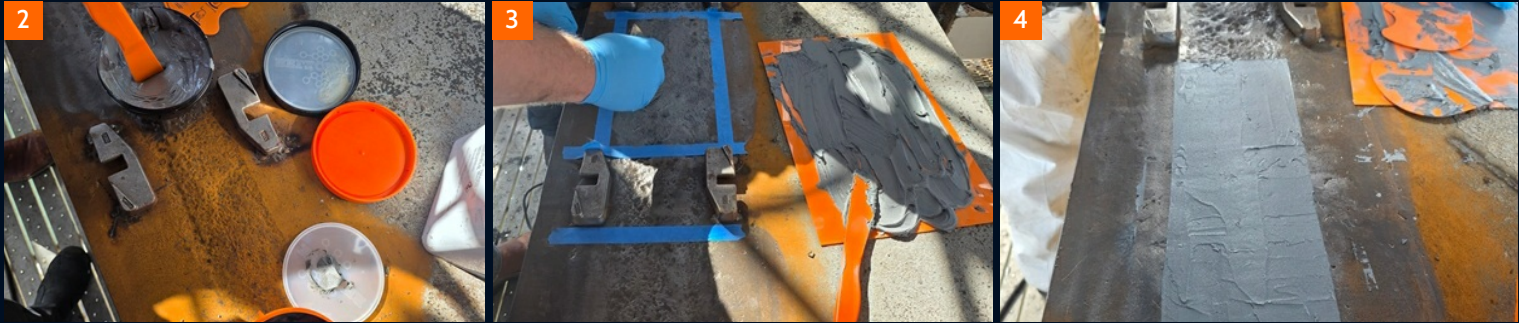
The trolley rail bed flanges have been corroding due to the aggressive environment and ponding rainwater. The inevitable pitting was affecting the functioning of the cranes.

1. Zoom out picture of one of the cranes.
2. Condition of the rail bed flange before surface preparation
3. Belzona 1121 being applied
4. Application of Belzona 1121 completed in two sections

All metal surfaces were grit-blasted to SSPC-SP10 several days prior to the application. During application days, the same metal surfaces were prepared with power tools and cleaned/degreased with a solvent rich cleaner.
