# EXPANSION JOINT REPAIR

ID: 9965

Pharmaceutical

Kryoneri Greece

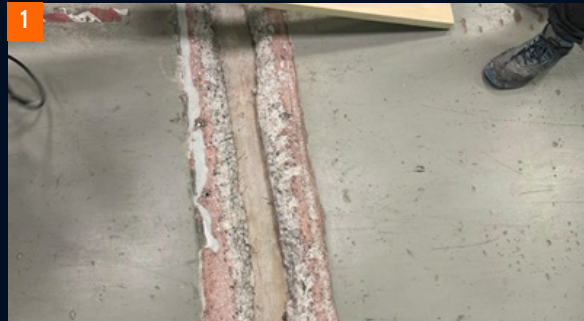
The expansion joint exhibited advanced deterioration, resulting in loss of movement accommodation and ineffective water sealing. This condition increased the risk of progressive substrate degradation and contributed to vehicle impact damage, including premature tire and suspension wear.

1. Initial surface condition
2. Belzona 4111 application
3. Belzona joint edge repair completed
4. Application completed
