# FLOOR COATING AND PROTECTION IN CHEMICAL TANK FARM WITH BELZONA 4311

ID: 9967

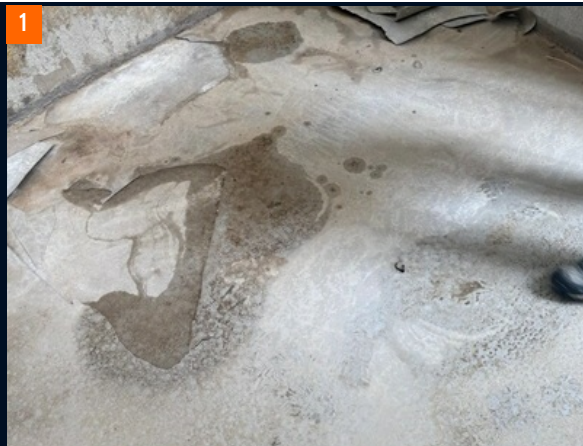
The tank farm floor, exposed to sodium hypochlorite (bleach), had suffered severe chemical attack. The old coating had lifted and peeled away, leaving bare, porous concrete that absorbed spills, was hard to clean, and offered no protection against further damage.

1. Failed previous coating
2. Surface preparation
3. Application of Belzona 4311
4. Application Completed
