# BELZONA REPAIRED PUMPS IN 1986 AND STILL RUNNING

ID: 997

7% sand in the main river water supply pumps wore out 3 pumps in under 7 years.

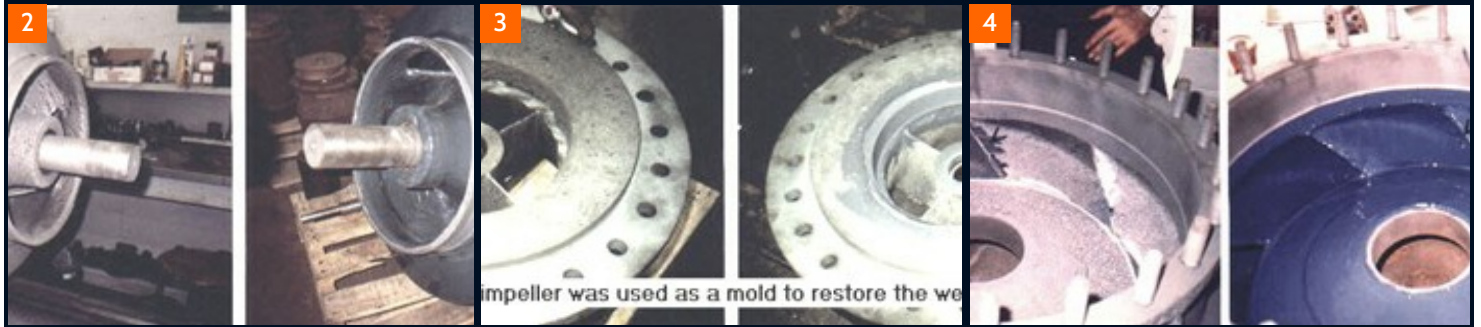
## PHOTOS

1. First impeller
2. Second impeller
3. Impeller fit to case with oversize impeller skirt, then impeller skirt cut to size.
4. Vane repairs with stiffening rods in place to define vane ends.

The application was carried out in accordance with the modified of Belzona Know-How System Leaflet FBC-2. Clean, prepare and apply.

Belzona 1311 (Ceramic R-Metal)  
Belzona 1321 (Ceramic S-metal)  
Belzona 9411 (Release Agent)
