# SF-6 LEAK SEALING ON BUSHINGS

ID: 9973

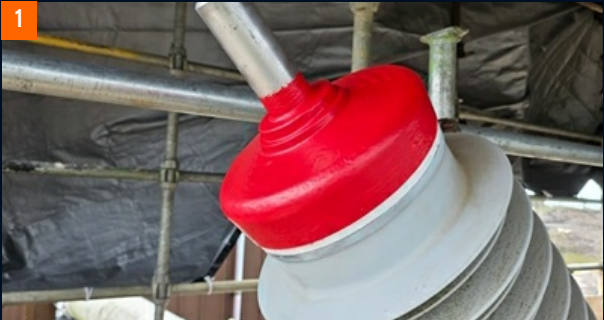
1. Existing coating this was removed & the surface prepared.
2. Wetting out substrate.
3. Belzona 7311 built up & Belzona 9341 reinforcement added.

The existing coating was removed & the surface prepared. Belzona 7311 was then built up with layers of Belzona 9341 reinforcement sheet.
