# PUMP BASE REPAIR & COATING WITH BELZONA

ID: 9974

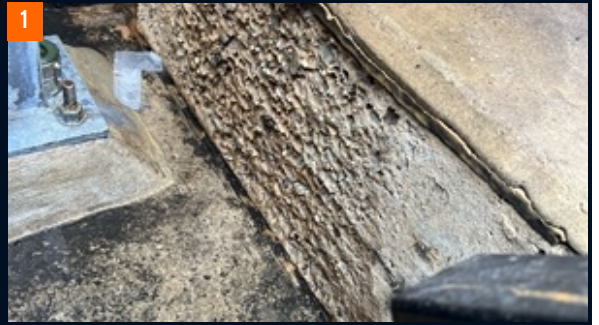
The concrete pump base had water running over it for several years due to constant water running over the pump to keep it from over heating. The water had been eroding the concrete for many years. They were facing the replacement of two pump bases.

1. Before Belzona concrete repair and coating picture
2. Damaged area on side of pump base.
3. Repaired crack area on side of pump base using Belzona 4111
4. Completed repair and coating of concrete pump base using Belzona 4111 and Belzona 5821

We used needle guns to prepare the surface area. Once the surface was prepared we then cleaned the concrete using a vacuum to remove dust and small debris and MEK to clean the surface.
