# BELZONA REPAIRS BRONZE IMPELLER

ID: 9975

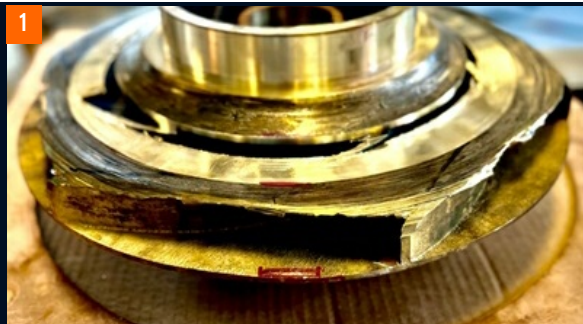
The customer was facing shutdown in their facility due to not having a backup impeller and long lead time for a new impeller.

1. Before Belzona repair and protective coating
2. Cutting it down to make it better
3. Top view of the repair using Belzona 1111 and brass plate
4. Completed repair of brass impeller using Belzona 1111 and Belzona 1321
