# RUBBER FLANGE REPAIR WITH BELZONA 2111

ID: 9976

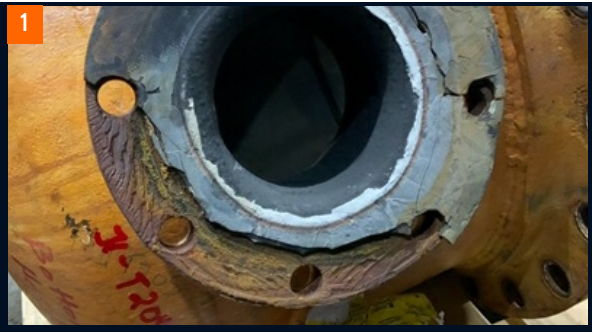
The customer was in outage and discovered the rubber lining of the condenser head was deteriorated and could not go back in to service.

1. Before Belzona 2111 repair
2. Once we removed the old rubber lining from the flange and prepped the surface we used shim stock to create a mold around the flange. Then we poured Belzona 2111 and let sit overnight.
3. The next day we removed the shim stock to reveal the completion of the Belzona 2111 repair to the flange.
