# FIRE PUMP CASING REPAIR & PROTECTION – IOL

ID: 9980

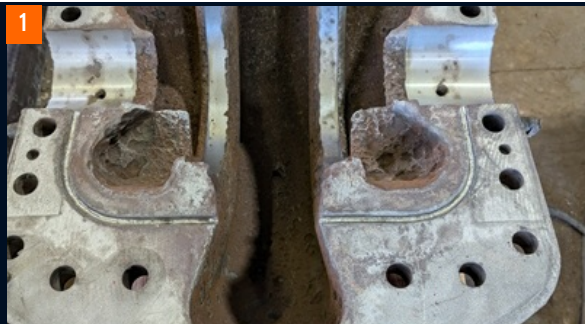
1. The pump house before the application
2. Severe pitting in the pump housing
3. Rebuilding with Belzona 1121
4. The pump house after the application of Belzona 1341

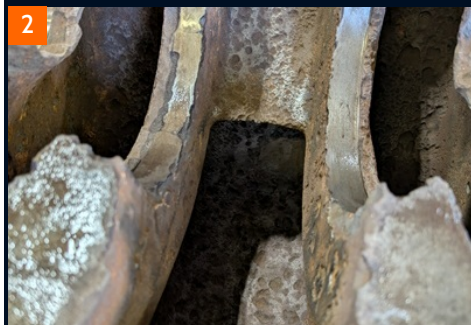
A critical fire pump casing at IOL was suffering from severe pitting and corrosion due to prolonged exposure to water. The deterioration risked further wall thinning, reduced efficiency, and potential leakage. Conventional repair methods (welding or replacement) would have been costly, time-consuming, and disruptive to plant operations.
