# BELZONA 3111 FLEXIBLE MEMBRANE SAVES ROOF AT NORTH DAKOTA MINE

ID: 9981

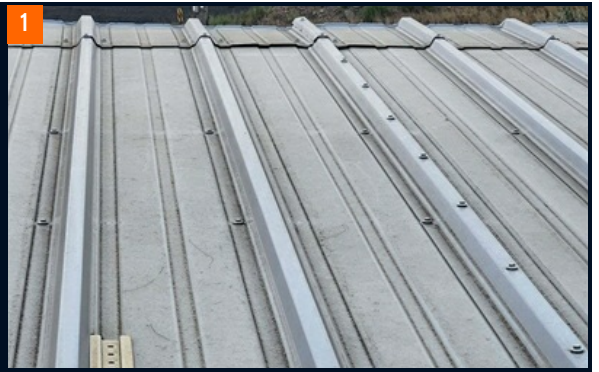
Roof area approximately 3500 sq ft had rust over 50% and very small holes and the seams were severely leaking. Building overhang out at unloading area at Mine.

1. Picture of roof before starting application
2. Prior to application of Belzona 3111
3. Belzona 3111 applied on 100% of roof with mesh installed on all seams fully reinforced.
4. Belzona 3111 flexible membrane fully reinforced roof.
