# TANK BASE SEALING ON OIL STORAGE TANK

ID: 9985

## PROBLEM

Corrosion develops under the floors of these tanks due to weather ingress. The floors are very expensive to replace.

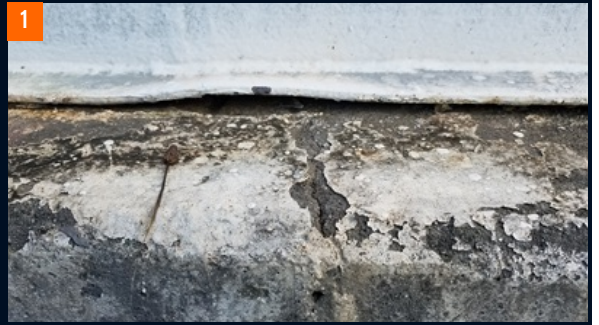
1. An example of the condition of the chime angle prior to any work starting.
2. Belzona 3931 (WG Membrane Conditioner) being brush applied.
3. Belzona 3131 (WG Membrane) being brush applied with 9351 reinforcing sheet.
4. Finished application. Customer will go back with their tank paint to touch up areas that were grit blasted but not coated.
