# PUMP BELL MOUTH REBUILT AND PROTECTED WITH BELZONA

ID: 999

Main raw water pump

Power Station, Pakistan

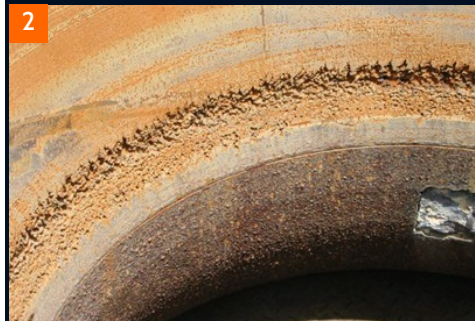
The pump bell mouth was badly eroded/corroded due to water quality.

1. Corroded Bell Mouth
2. Extent of the erosion apparent after grit blasting
3. Rebuilding with Belzona 1311
4. Completed job after applying Belzona 1341
