# REVIVED WATER PUMP WITH BELZONA

ID: 9990

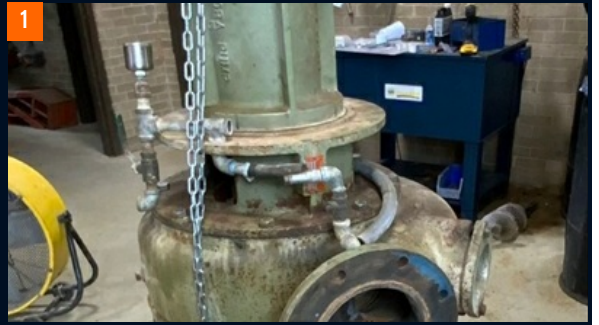
This pump is 30 plus years old and was in need of exterior restoration due to the environment it lives in.

1. Before Belzona restoration.
2. Preparing for blasting and cleaning
3. Final touch ups using Belzona 5811
4. Finished results
