# BELZONA EXTENDS LIFE OF CLARIFIER

ID: 9992

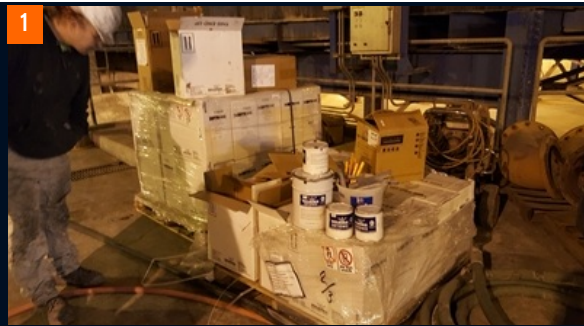
1. Belzona 5811DW2 has arrived on site.
2. Application started on clarifier. The whole clarifier is covered with plastic.
3. Application of Belzona 5811DW2 by brush to the legs of the clarifier
4. Photo of clarifier in use after Belzona application
