# BELZONA REPAIRS LEAKS IN COOLING TOWERS AND EXTENDS THEIR LIFESPAN

ID: 9995

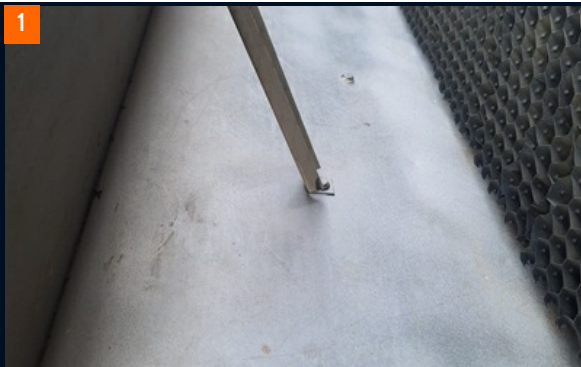
1. Surface preparation prior to Belzona systems being applied
2. All the existing silicon's removed
3. All the joints are sealed with Belzona elastomer 2211 (MP Hi-Build Elastomer) and Belzona 2221 (MP Fluid Elastomer)
4. Application of Belzona 5811 (Immersion Grade) was carried out to enhance the protection of the cooling tower base

1. Surface preparation: The cooling tower base and joints were cleaned and blasted to remove failed sealants, dirt, and contaminants.
2. Conditioning: Belzona 2911 (Elastomer QD Conditioner) was applied to ensure maximum adhesion.
3. Sealing: Joints were rebuilt and sealed using Belzona 2211 (MP Hi-Build Elastomer) and Belzona 2221 (MP Fluid Elastomer) for flexibility and resilience.
4. Protection: The base was over-coated with Belzona 5811 (Immersion Grade) to provide chemical and corrosion resistance in continuous immersion service.
