# BELZONA REPAIRS & PROTECTS DREDGE APPARATUS PIPING

ID: 9998

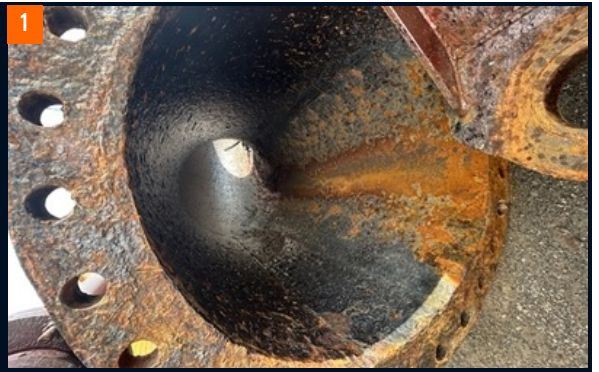
Customer was taking apart dredge apparatus after being in service continuously for over 6 years. Piping was heavily eroded with multiple through-wall holes (not pictured). Customer needed to get dredge apparatus back to work on contract within 1 month. Customer chose Belzona for a repair and coat system rather than spending several hundred thousand on new equipment.

1. Dredge pipe after being taken down from apparatus.
2. Dredge pipe after being blasted by application team.
3. Dredge pipe after bottom half coated with Belzona 1814 working outward from center. Pipe was flipped over to complete job while making for easier application.
4. Dredge completely coated with Belzona 1814.

Dredge pipes were cleaned and blasted to SSPC-SP10 for surface prep. The through-wall holes were rebuilt with Belzona 1311/9341 and then entire pipe internals were coated with Belzona 1814.
