BELZONA REBUILDS KORT NOZZLE

ID: 3128

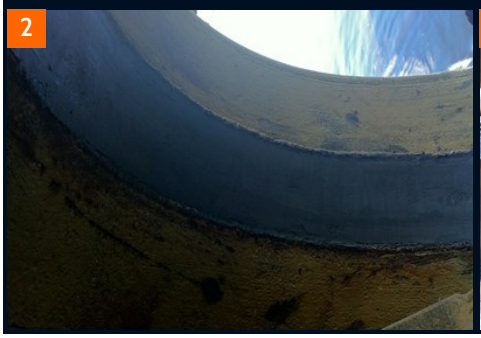
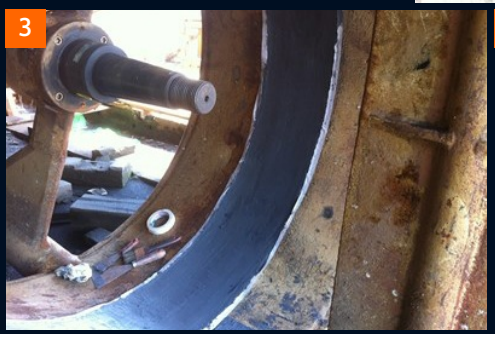
PHOTOS

PROBLEM
OnlY 16 hours was available to carry out repairs to the erosion damage.

APPLICATION SITUATION
Badly corroded kort nozzle

1. Eroded area
2. Belzona 1311 aplication
3. Completed Belzona 1311 aplication
4. Vessel ready to refloat.

APPLICATION METHOD
Application was carried out in accordance with Belzona Know-How System Leaflets SOS-1. After grit blasting, Belzona® 1311 was used to rebuild eroded metal and provide future erosion corrosion protection.
