# BELZONA KEEPS HOSPITAL LAUNDRY BILLS DOWN

ID: 140

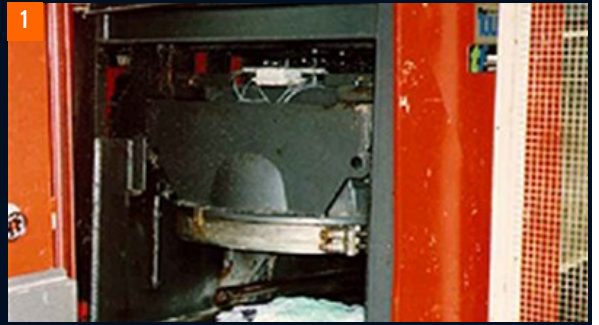
Wear and tear in service causes splits, in addition to mechanical damage caused by sharp objects left in clothing (a common occurrence).

1. The laundry press in operation
2. Typical split prepared and ready to have Belzona applied
3. Completing the Belzona 2211 application

Application was carried out in accordance with Belzona System leaflet VPF-5.

Typical Belzona repairs cost £10-20 as opposed to a new diaphragm at over £1400. At this hospital some diaphragms have been repaired 5 and 6 times.
