# BELZONA REPAIR ON 10,000 HP SULZER MARINE DIESEL ENGINE

ID: 249

## PROBLEM

Pitting corrosion on engine block caused o-ring seals to leak.

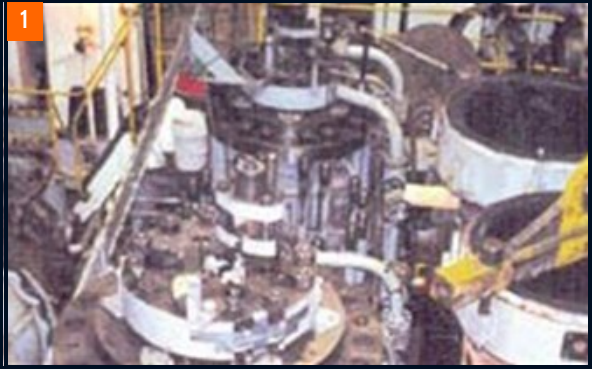
1. View of Sulzer Engine
2. Close-up of pitted, corroded area on engine block
3. Prepared area after machining, before Belzona
4. View of machined Belzona

The application was carried out in accordance with a modified version of Belzona Know-How System Leaflet ENC-5.

Belzona 1111 (Super Metal)
