# CAVITATION DAMAGE TO THIS TANKER PROPELLER REPAIRED WITH BELZONA

Cavitation damage to a 12-foot diameter tanker propeller.

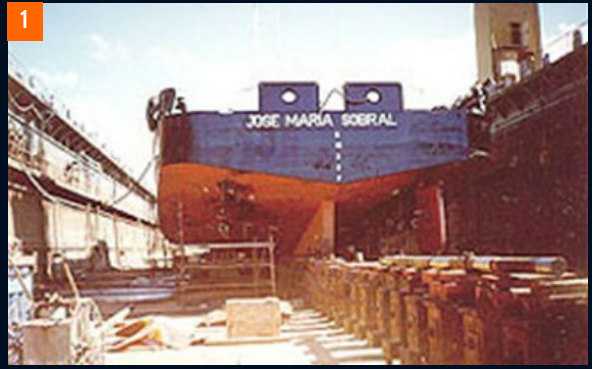
The large difference in pressure on the edges of this bronze propeller caused cavitation bubbles that in turn damaged the metal substrate after imploding onto the surface.

The application was carried out in accordance with Belzona Know-How System Leaflet SOS-2.

Belzona 1321 (Ceramic S-Metal)  
Belzona 1311 (Ceramic R-Metal)
