# RUBBER TRACKS ON MOBILE DRILLING RIG QUICKLY REPAIRED WITH BELZONA

ID: 4683

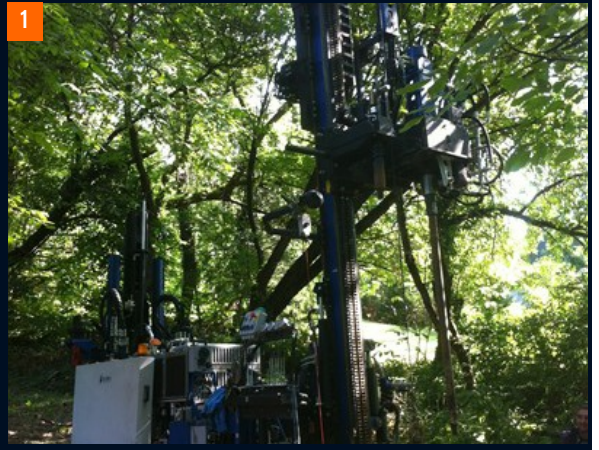
Several damaged areas on its rubberized tracks required quick repair to prevent track failure.

1. Geo drilling machine on site
2. One of the damaged areas on the tracks
3. Damaged area after surface preparation and Conditioning
4. Application finished.

The application was carried out in accordance with Belzona System Leaflet SHM-1.
