# BELZONA REPAIRS PROFILE OF HYDROELECTRIC DAM

ID: 5285

Rebuilding the profile of a small hydroelectric dam.

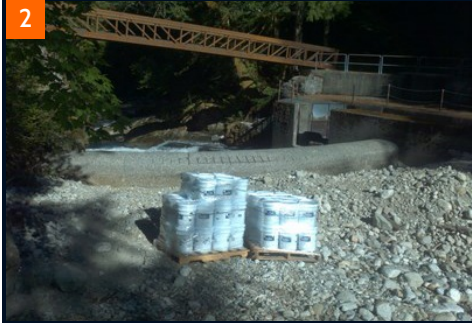
The profile of a small hydroelectric dam became worn, exposing reinforcing bar, which was caused by damage from VW sized boulders tumbling into and over the face of dam during spring runoff. The client was concerned about maintaining the integrity of the small hydroelectric dam and restoring the original profile.

1. Dam (ogee) profile before repairs
2. Several pallets of Belzona 4111 on site
3. Dam repairs underway - note templates & mixer
4. Completed application

With the help of plywood templates, the dam profile was rebuilt with Belzona 4111 applied by hand. The application time was limited due to possible mountain runoff. Work was tightly monitored and contained so as not to pollute nearby fish spawning grounds.
