# BELZONA REINFORCES AND PROTECTS TURBINE

ID: 5323

GE Turbine.

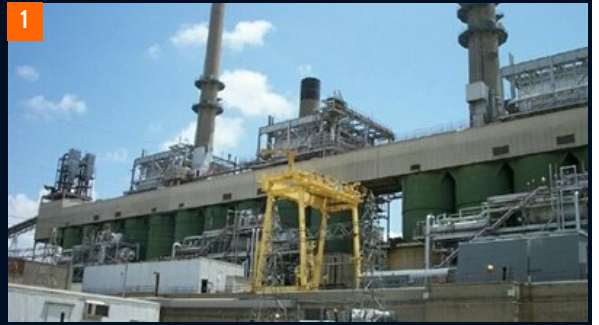
1. Overview of the Power Plant
2. Stationary diaphragms removed for inspection
3. Blades showed signs of erosion so they were rebuilt
4. Application carried out for all four diaphragm halves showing one of the four finished repairs
