# BELZONA SCRUBBER HEADER PATCHED

ID: 67

Fiberglass header in scrubber unit

Power Plant in North Texas

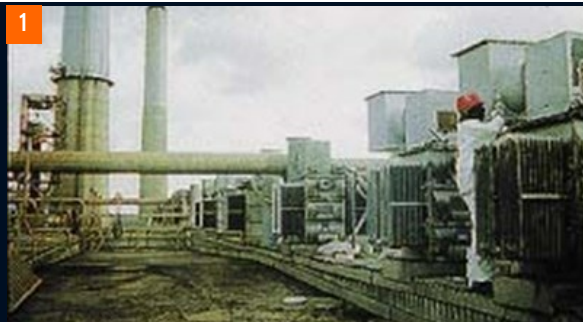
Scrubber nozzles spray lime slurry to neutralize flue gas. Nozzle gets plugged or worn, redirecting a side stream that tears holes in fiberglass headers.

1. A view in the plant
2. Fiberglass header in scrubber unit
3. Header patched with Belzona 1811

The application was carried out in accordance with a modified version of Belzona Know-How Leaflet TCC-3.

Belzona 1811 (Ceramic Carbide)
