# BELZONA SEALS LEAK IN WIND TURBINE TOWER

ID: 8068

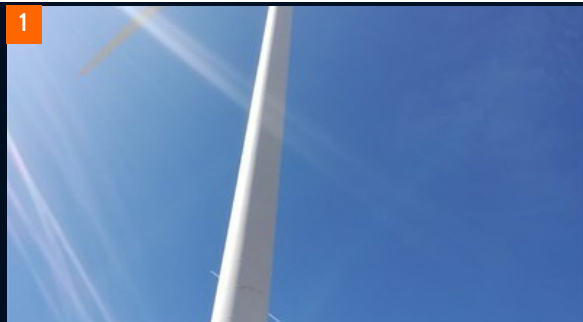
1. Wind Turbine view from the ground
2. View from the top of the tower
3. Leak sealed with Belzona 9611
4. Completed repair
