# ENGINE REPAIR WITH BELZONA

ID: 854

Komatsu 900 loader.

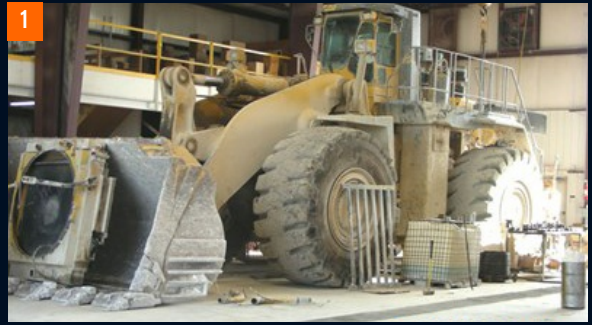
Erosion/corrosion on the cylinder block behind the cylinder liners allowed engine coolant to leak into the lubricating oil causing an engine failure.

1. Komatsu 900 loader
2. Typical damage
3. Completed surface preparation
4. Finished repair to 1 of the 11 damaged areas

Application carried out in accordance with Belzona Know-How System Leaflet ENC-6. Particular attention paid to removing entrained antifreeze before preparing surface and applying Belzona.
