# GALVANIC CORROSION IN WATER MAKER REPAIRED WITH BELZONA

ID: 908

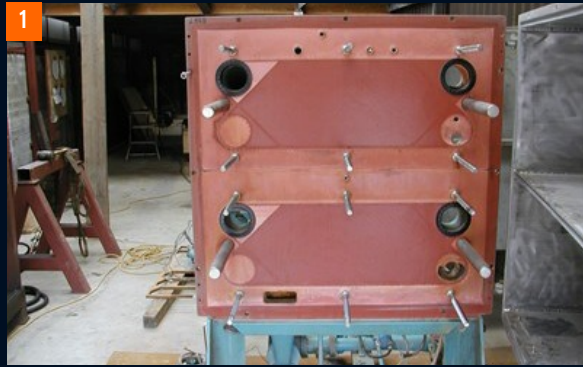
Galvanic corrosion caused by the failure of the insulating gasket caused severe corrosion and under cut the existing glass flake coating. Base material was Carbon Steel plates were Titanium.

1. Water Maker
2. One of the areas of galvanic corrosion
3. Forming the repair
4. Repair completed, perfectly formed flange face

Application completed in accordance with Belzona System Leaflet VPF-13.
