# BELZONA REPAIRS A BALCONY

ID: 8036

Repair of a 2nd floor apartment balcony in the center of Zagreb.

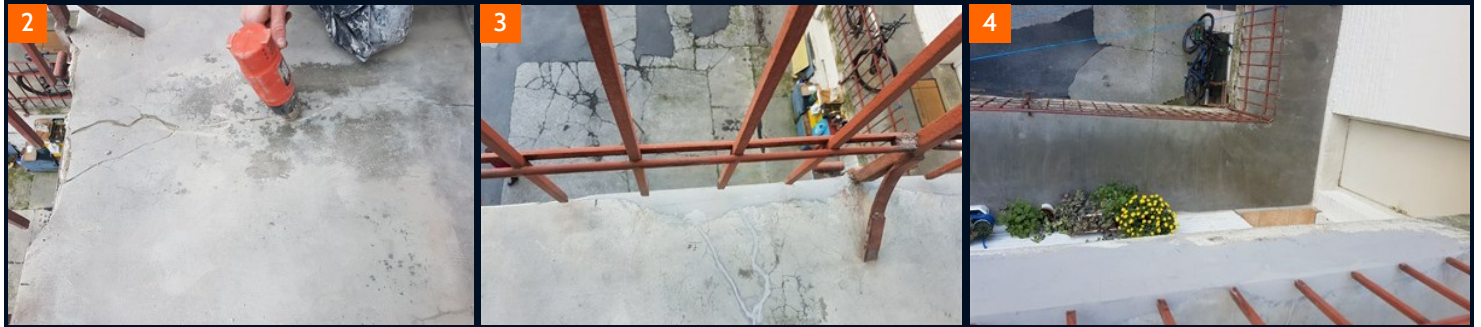
1. Damaged balcony.
2. Surface preparation, drying after washing.
3. Application completed.
4. Application completed (side view).

Application was carried out according to FPA-1. Loose parts of the concrete were removed before the surface was cleaned and conditioned. Exposed rebar was thoroughly cleaned and abraded with an MBX Bristle Blaster. The balconies were then resurfaced with Belzona 4111. Cracks were deepened to at least 6 mm, cleaned and filled with Belzona 4111.
