# BELZONA REPAIRS PUMP MOUTH

ID: 8797

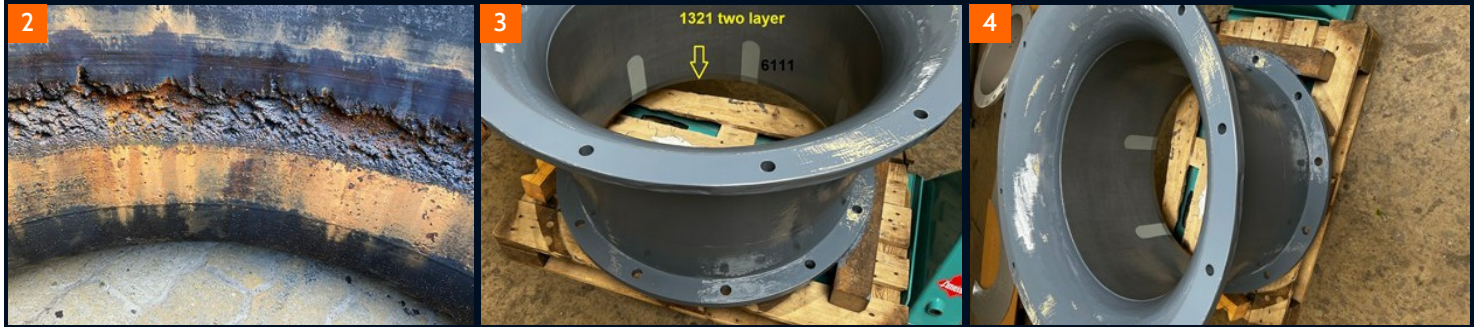
Image 1: Pump Mouth to Repair

Image 2: Close up heavy corrosion

Image 3: Belzona Products Applied

Image 4: Complete Application

Heavy corrosion in the area where the propeller runs.

After blasting in accordance with Belzona standards the corroded areas were filled with Belzona 1311 and then coated the complete inside with two layers of Belzona 1321. The upper part we overcoated and then the external coating was coated with Belzona 5821. Please refer to Belzona systems leaflets CEP-03 & CEP-05 for further details of products that can be used for this type of application.
