# STEEL MILL OFFICE FLOOR PROTECTED WITH BELZONA 5231

ID: 10020

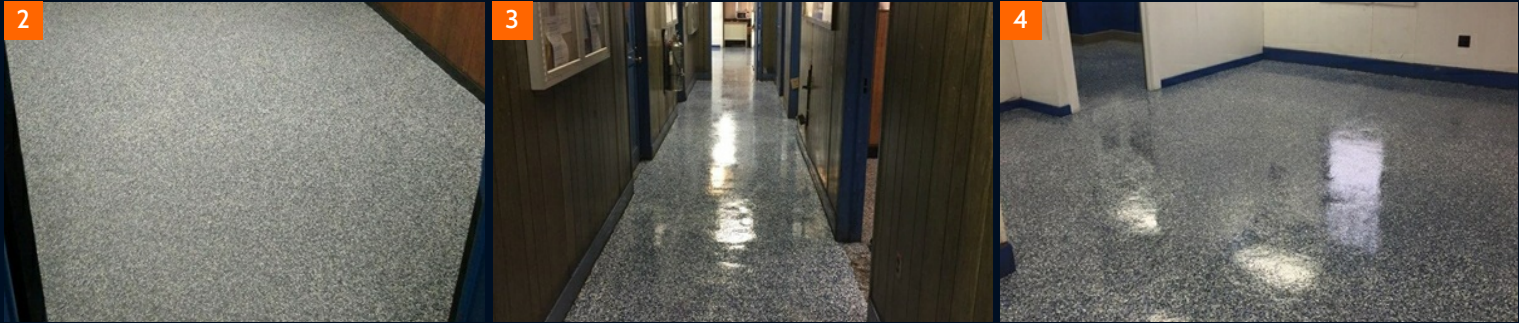
- 1. The office floors were in this condition
- 2. Belzona 5231 applied with non slip material
- 3. Belzona 5233 was applied as a top coat
- 4. Finished application

The floors were prepared with a Blastrac machine. Belzona 5231 was applied. The "shark's teeth" aggregate was broadcast and a topcoat of Belzona 5233 was applied.
