# LOUISIANA CHANNEL’S THE BELZONA 5821

ID: 10044

**PROBLEM**  
Corroded and pitted channel head, divider plate and end cover

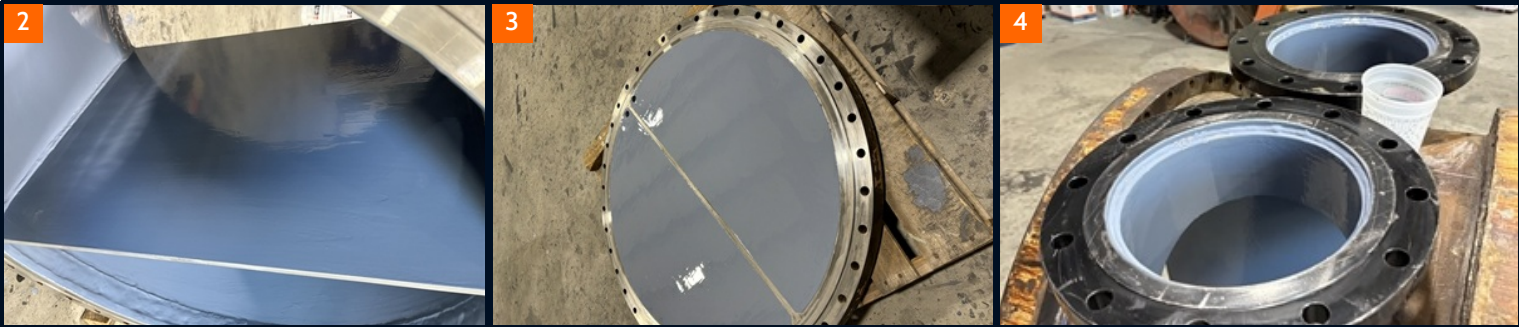
- PHOTOS**
1. When the channel head was delivered
  2. The channel and divider plate rebuilt with Belzona 1121 and protected with two coats of Belzona 5821
  3. End plate after Belzona 5821 was applied
  4. Top of Channel head

**APPLICATION METHOD**  
We grit blasted to a 3 mil angular profile. Applied Belzona 1121 to smooth substrates and fill pitting. Brushed on two coats of Belzona 5821 for protection.
