# BELZONA SLOPES CATALYST

ID: 10089

Chemical & Petrochemical

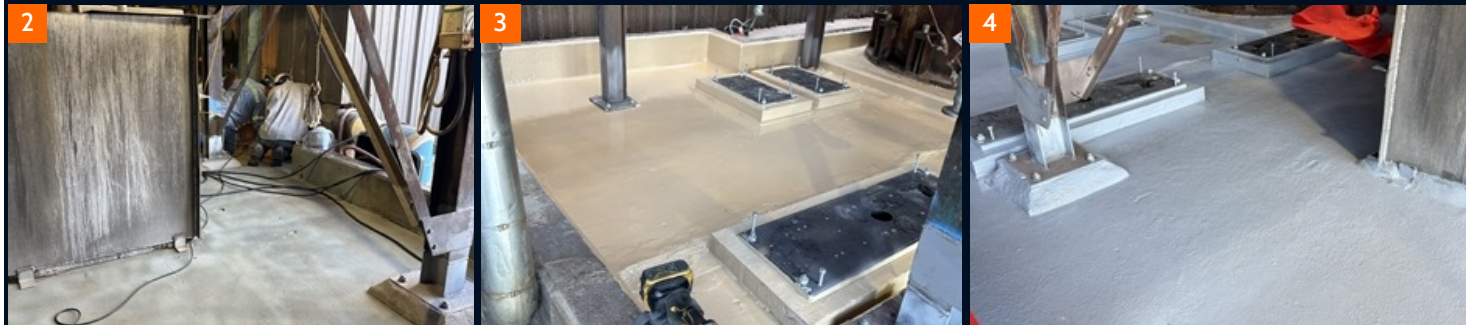
## PHOTOS

Concrete was deteriorating because lack of protection from the chemicals over time.

1. Contractors setting up the pump bases.
2. Containment after being cleaned and grit blasted.
3. Containment during first coat of Belzona 5811.
4. Containment after top coat of Belzona 5811.

Grit blasted area with aluminum oxide, troweled on Belzona 4124 to make floor to wall transitions. Applied two coats of Belzona 5811 using brushes.
