# RAMPS AND LANDINGS WITH BELZONA 4151

ID: 10108

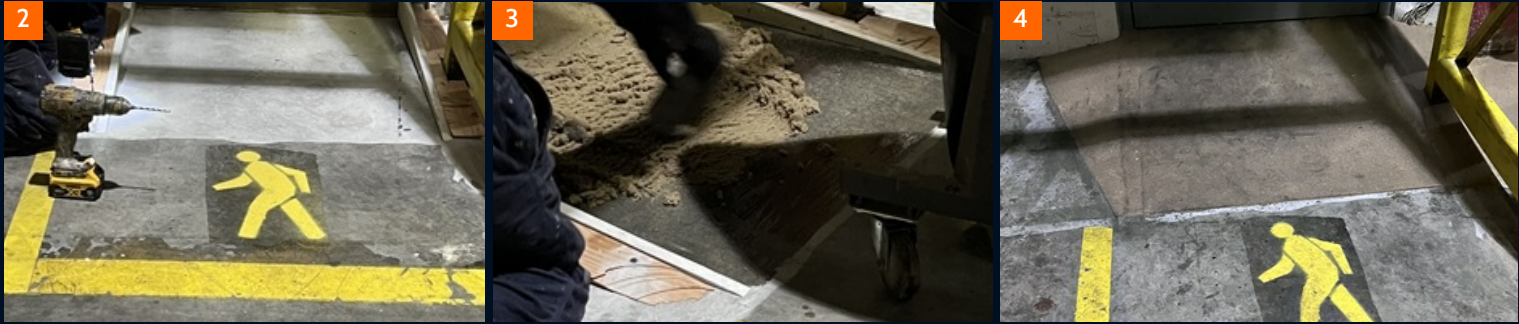
1. We first cleaned and prepared the concrete using surface grinders.
2. Next we built the forms to contain the Belzona 4151 with added aggregate to create a smooth edge and proper height.
3. Then we mixed the aggregate with the Belzona 4151 to the consistency recommended to create a flowable but firm mixture.
4. To finish, we removed the forms after the recommended cure time and opened the doorway back up to pedestrian traffic.

For the application process we first started off by removing any dirt and debris then we used hand grinders and walk behind grinders with vacuum attachments for minimal dust. When grinding was complete we removed all dust and debris once again then applied Belzona 4911 Conditioner to the surface area for 20 minutes before applying Belzona 4151 with aggregate. We used hand trowels for the finishing touch.
