# MASSIVE SEAWATER EVAPORATOR PROTECTED WITH BELZONA 5892 AT A POWER PLANT IN SAUDI ARABIA

ID: 10118

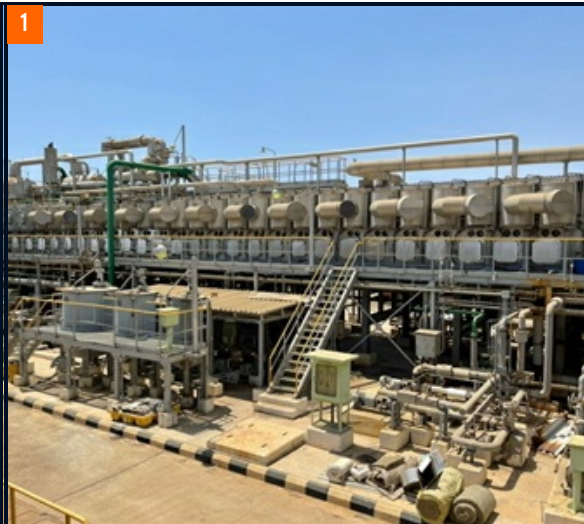
1. General overview of the seawater evaporator
2. Condition before Belzona 5892 application
3. After grit blasting surface preparation and salt testing
4. Completed application of Belzona 5892 system

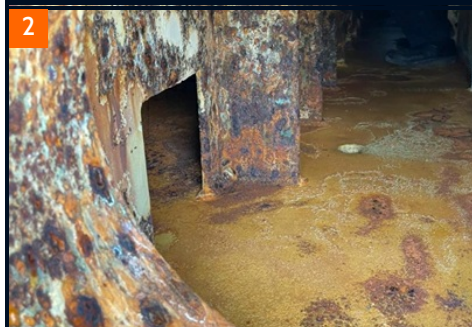
A seawater evaporator at a power plant in Saudi Arabia was facing a severe internal corrosion issue.
