# ROOF COATING WITH BELZONA 3111

ID: 10135

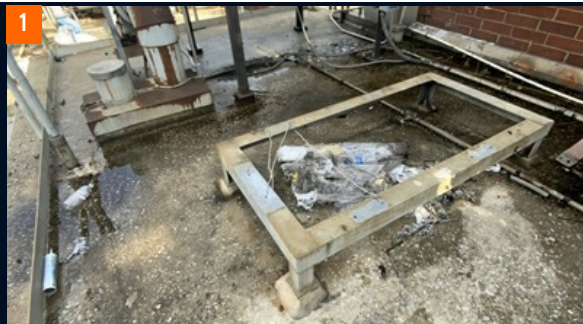
The roof is almost fifty years old and was facing deterioration due to no protection from sun, rain or UV.

1. You can see in this photo the water standing due to poor slope and deep pitting in the concrete caused from deterioration.
2. After pressure washing the roof we applied Belzona 3911 Conditioner.
3. Next we applied four coats of Belzona 3111 to help fill the pitting and create a complete seal.
4. Completed roof coating project using Belzona 3911 and 3111.
