# BELZONA 1984 SURFACE TOLERANT SUPER WRAP II

ID: 10144

## PROBLEM

The client was dealing with a serious issue of thin walled piping.

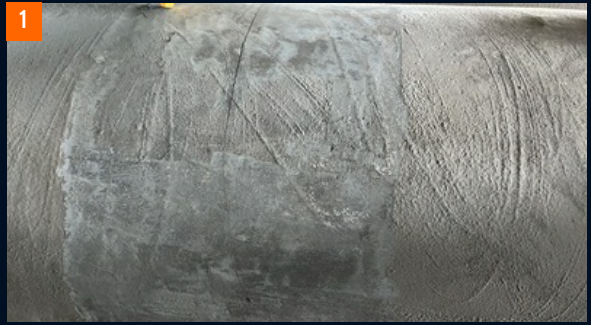
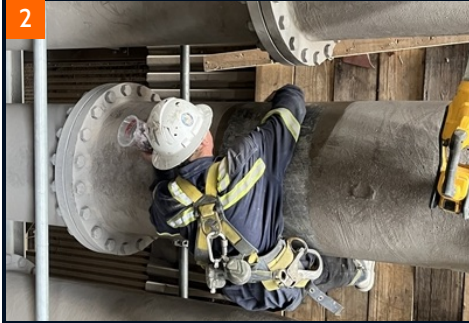
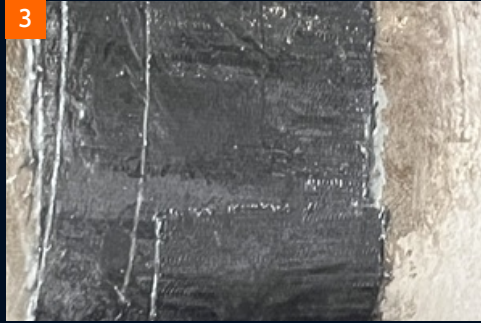
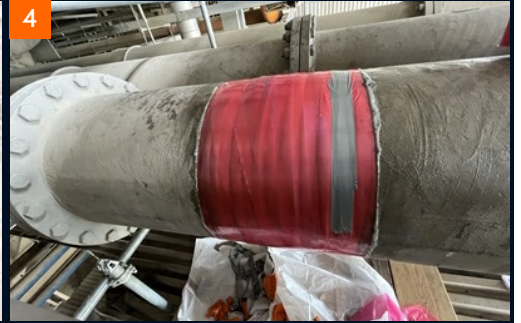
## PHOTOS

1. This picture allows you to see how we prepped the surface with a MBX bristle blaster.
2. The photo show you how large this pipe was compared to one of our applicators.
3. Here you can see we wrapped the pipe with three Belzona Carbon-Glass Fiber Super Wraps.
4. Completed photo of Belzona 1984 Carbon-Glass Fiber Super Wrap II

For this application we used an MBX Bristle Blaster and a grinder to prepare the surface. Followed by cleaning with 100% non-recycled MEK. Once the pipe was prepped and cleaned we the pre-fit the Belzona Super Wrap II then cut three wraps. Then we pre-fit the consolidation tape. Followed by mixing Belzona 1984 to Belzona specs. Next we mixed the 1984 into the Super Wrap II and applied to the surface area followed by applying the Super Wrap II to the pipe with three separate wraps to ensure proper thickness. Finally completing the wrap system by applying the red consolidation tape. We used a temperature reader along with surface temperature and humidity readings to ensure proper working environment. This application required a six month inspection by the client. It was recently inspected in October 2025 and was passed by client and contractor.
