# BELZONA 1984 SUPER WRAP II

ID: 10147

## PROBLEM

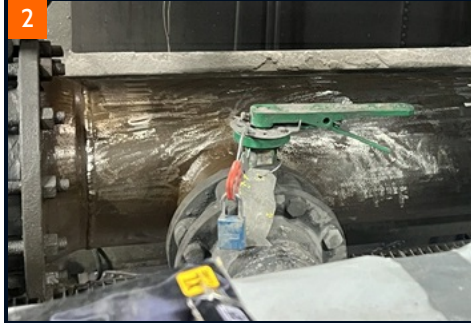
1. Removing build up and rust before applying Belzona 1984.
2. Prepping the surface with grinders and MBX Bristle Blaster.
3. Up close of applying Belzona 1984 and Super Wrap II
4. Completed Belzona 1984 Super Wrap II

Using handheld grinders and a MBX Bristle Blaster we prepared the surface by removing years of buildup and rust. Followed by cleaning the surface using 100% MEK. Next, we pre-fit and cut the Carbon Fiber Super Wrap II three times for a 3-wrap system followed by pre-fit and cut of the consolidation tape. To complete the application, we applied Belzona 1984 to the pipes surface then to the Carbon-Glass Fiber Super Wrap II. Applying each wrap one at a time followed by the consolidation tape.
