# BELZONA 4181 TRENCH AND CONTAINMENT PROTECTION

ID: 10184

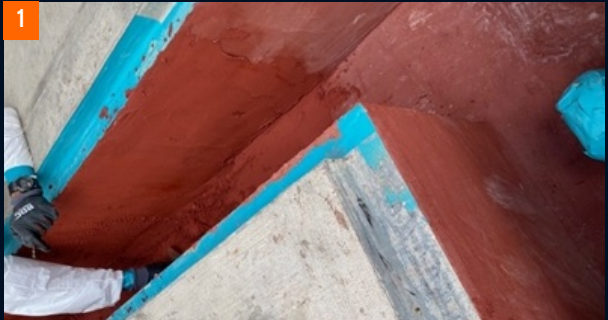
1. Belzona 4181 AHR Magma Quartz being applied to new build 2022.
2. Dump pit halfway completed with Belzona 4181AHR Magma Quartz.
3. Completed secondary containment area.
4. After four years of service, all areas are still in excellent shape when viewed in 2026 during routine cleaning and inspection.

Concrete areas were allowed to cure for over 28 days. Surface was blasted and power washed. Application of Belzona 4181 was carried out by hand trowel.
